NSPS 0000a Annual Report

Oxy Permian Resources New Mexico Delaware Basin

Initial Reporting Period: 9/19/2015 – 8/2/2017

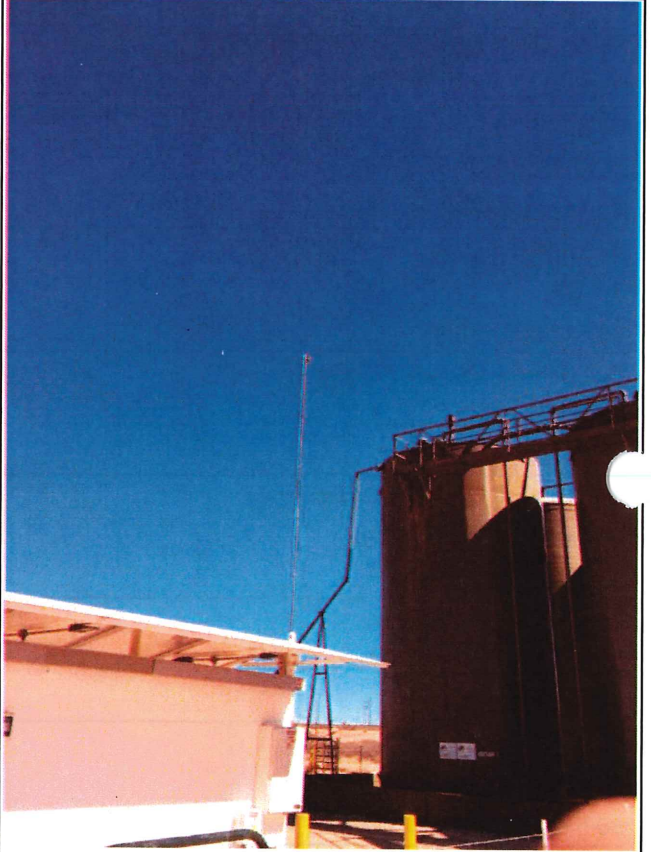
Type of Leaking Component?	Describe Leaking Component Location	Take iPhone photograph of leaking component and identify location.
Enardo Valve (PVRV) 60.5420a(b)(7)(vii) 60.5420a(b)(7)(viii)	Oil tank 1 common tank vent enardo 60.5420a(c)(15)(ii)(l)(8)

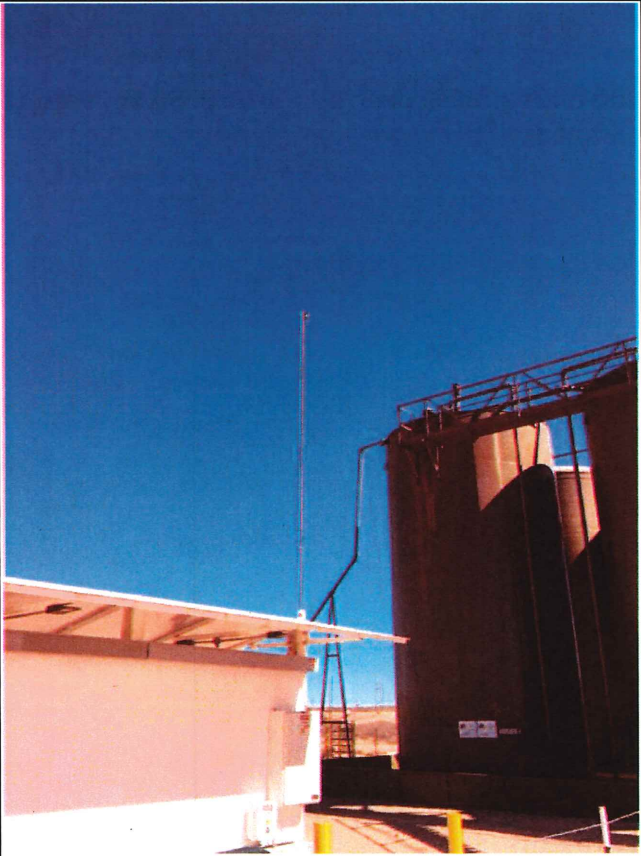
Type of Leaking Component?	Describe Leaking Component Location	Take iPhone photograph of leaking component and identify location.
Thief Hatch 60.5420a(b)(7)(vii) 60.5420a(b)(7)(viii)	Oil tank 1thief hatch 60.5420a(c)(15)(ii)(l)(8)

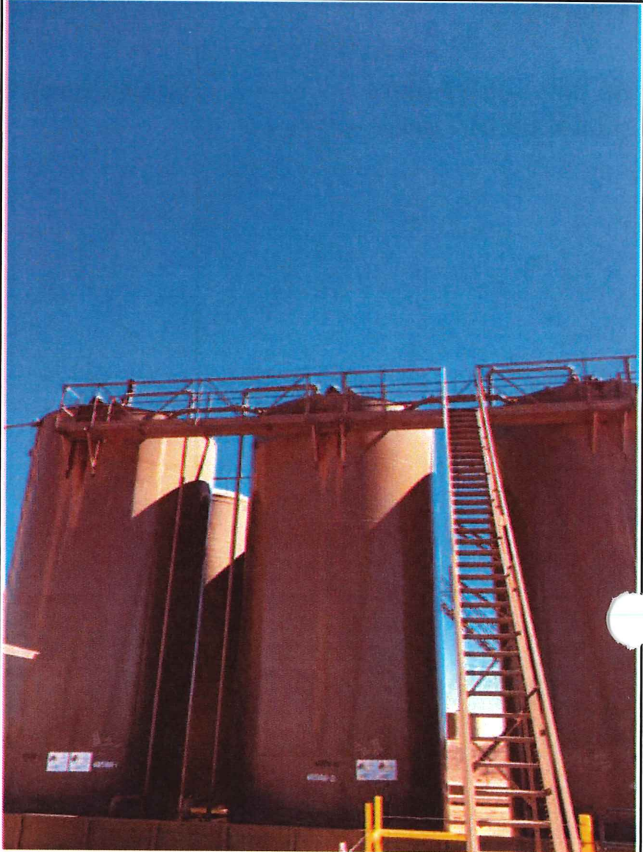
Type of Leaking Component?	Describe Leaking Component Location	Take iPhone photograph of leaking component and identify location.
Thief Hatch 60.5420a(b)(7)(vii) 60.5420a(b)(7)(viii)	Oil tank 2 thief hatch 60.5420a(c)(15)(ii)(I)(8)

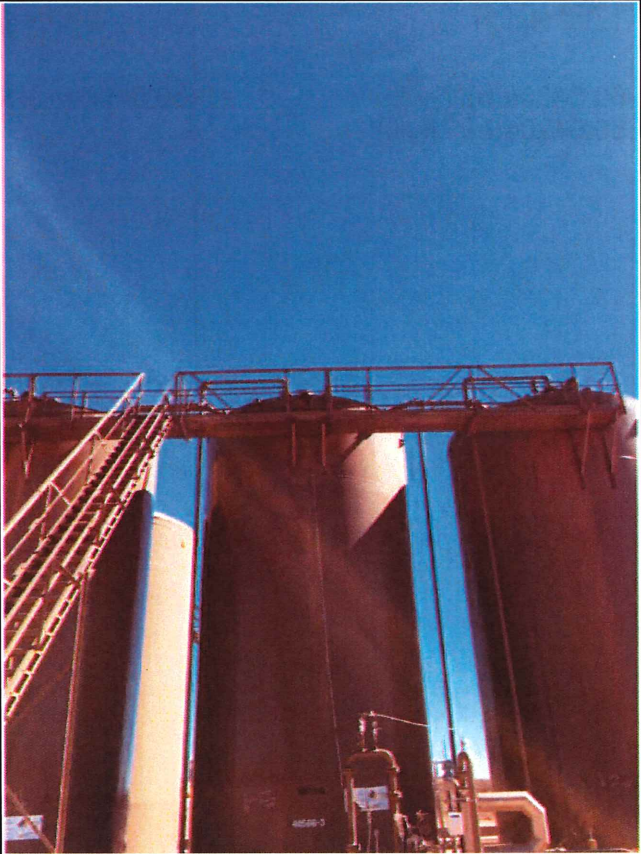
Type of Leaking Component?	Describe Leaking Component Location	Take iPhone photograph of leaking component and identify location.
Thief Hatch 60.5420a(b)(7)(vii) 60.5420a(b)(7)(viii)	Oil tank 3 thief hatch 60.5420a(c)(15)(ii)(l)(8)

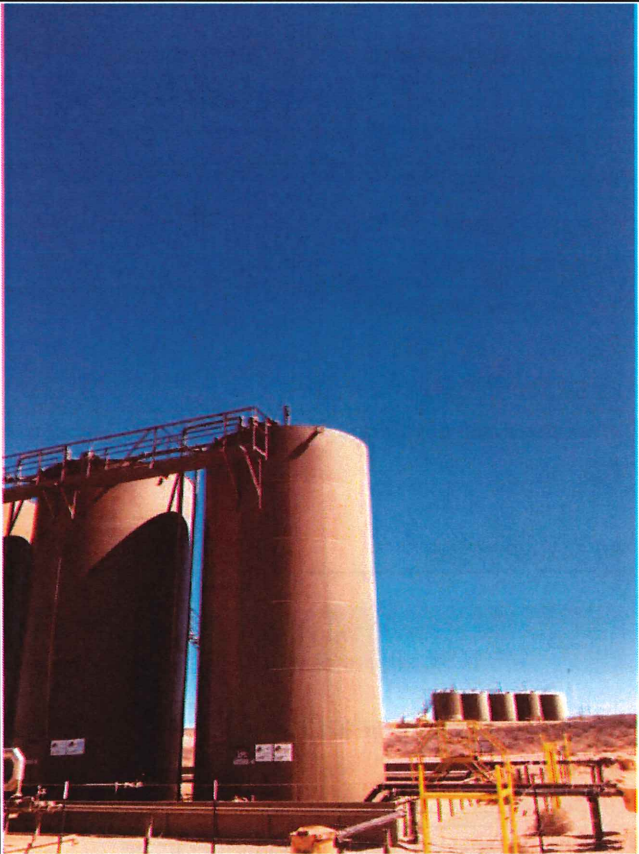
Type of Leaking Component?	Describe Leaking Component Location	Take iPhone photograph of leaking component and identify location.
Enardo Valve (PVRV) 60.5420a(b)(7)(vii) 60.5420a(b)(7)(viii)	Oil tank 4 common tank vent line enardo 60.5420a(c)(15)(ii)(l)(8)
